Research Article

ESTIMATION OF SEISMIC DAMAGE PROPAGATION IN A HISTORICAL MASONRY MINARET

Keywords: Masonry minaret; Operational modal analysis; Ambient Vibration Testing; Damage Estimation; Concrete damage plasticity model.

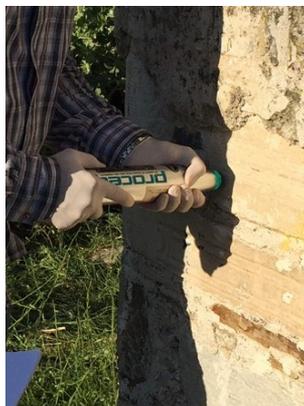
The minaret has a stone masonry base and brick masonry body. Since it is considered as a historical heritage, core sampling for the tests was not allowed. Some of the fallen stones were taken and tested with density-porosity and load point tests. L and LB type Proceq Schmidt Hammers were used to detect the surface hardness values (rebound value) of the stone and clay brick samples, respectively as shown in Fig. 2. The material properties were determined using density porosity tests and rebound values [15-16]. Collected properties are given in Table 1.

Figure 2. Schmidt hammer test [14]

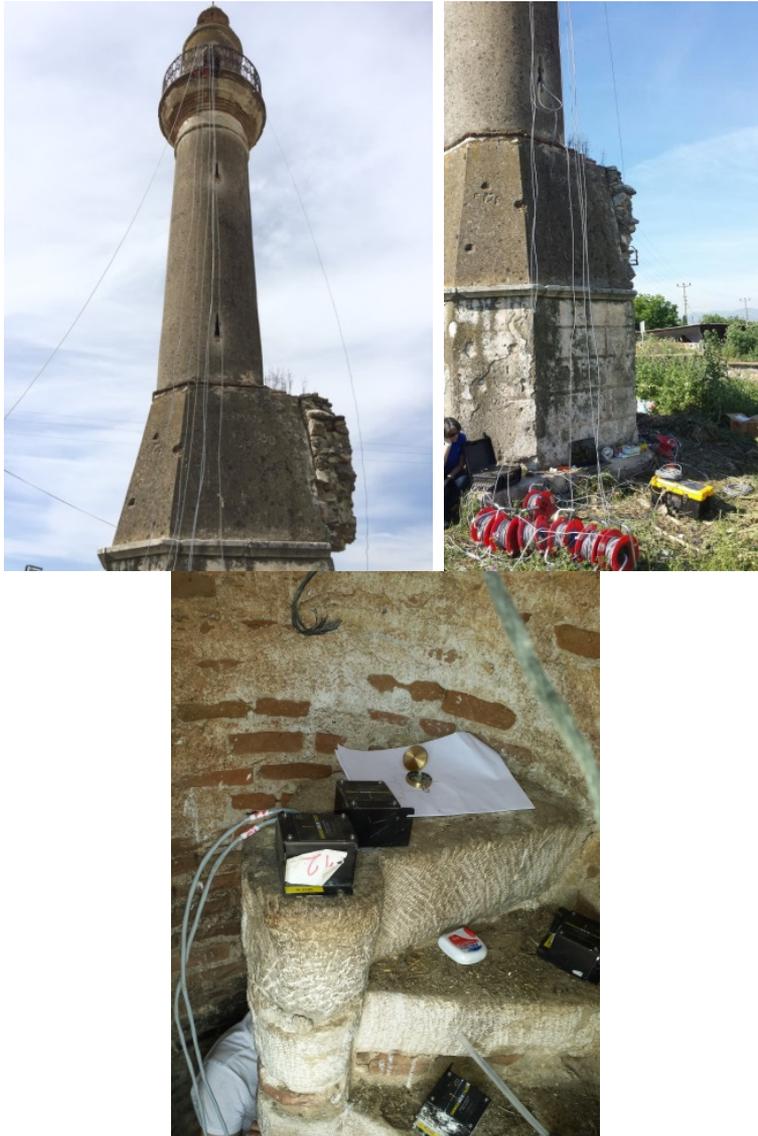
In order to collect dynamic characteristics of the minaret and to decrease the measuring errors, three ambient vibration tests were conducted (Fig. 6). Total of 14 uniaxial accelerometers were used, their locations are shown in Fig. 7. Acceleration data acquired from accelerometers were gathered in a 16 channel data acquisition system Testbox 6501 (Fig. 7). Modal parameters were then extracted using ARTeMIS Modal Pro software by using the SSI method [26].

Figure 6. OMA test of the minaret.

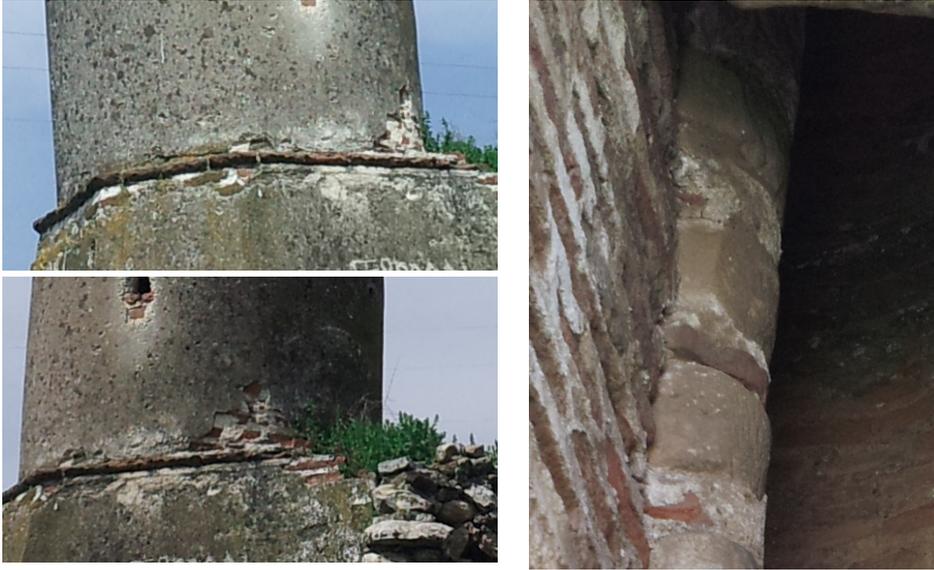
Both in linear and in nonlinear analysis, the largest tensile and compressive stresses in the structure occurred at the same regions. Besides, the expected damages in the analysis and the existing cracks overlapped as seen in Fig. 21. This result indicates that both methods, linear and nonlinear, are successful to determinate possible damage locations. Overlapping of existing damages and damages obtained from FE analysis indicates that calibrated FE model by OMA is realistic to exhibit actual behavior. The tensile stresses obtained from the linear analysis were found to be 13 times higher than the material strength for Çay earthquake, and 58 times higher than the material strength for Düzce earthquakes. On the other hand, the tensile stresses obtained from the nonlinear analysis were found to be only 4 times higher and 9 times higher than the material strength for Çay and Düzce earthquakes, respectively. It is seen that the minaret was damaged under the effect of Çay earthquake in linear FE analysis, whereas only few members passed critical plastic strain level in nonlinear FE analysis, and in fact, the minaret would not be damaged, at all. On the other hand, the tensile plastic strains gathered from nonlinear FE analysis under the effect of Düzce earthquake exceeded the critical material strain value indicating that there would be serious damages in the minaret in case of severe earthquake. Contrary to that, the compressive strength gathered from both analysis methods, linear and nonlinear, would not have caused damage, so the minaret is safe against compressive stresses.

Figure 21. Existing cracks and damages on the minaret
