Research Article

AN EVALUATION FOR PREVENTING CROSS-HATCHED AREA VIOLATIONS ON HIGHWAYS

Erinç Ezgi DOĞAN¹, Mustafa GÜRSOY*²

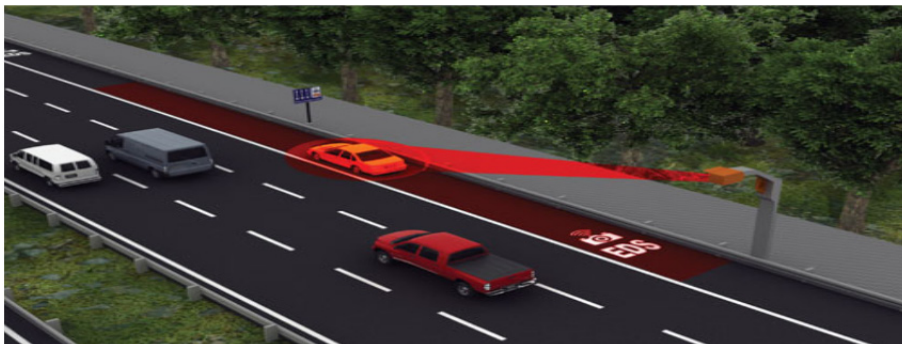
Figure 2. An electronic supervision system (EDS) example (4)

An example of an electronic supervision system (EDS or (TEDES in Turkish)) can be seen in Figure 2.

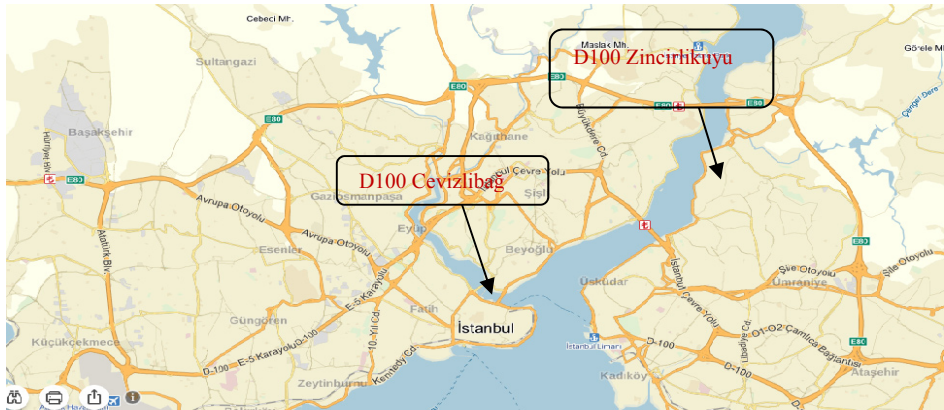
Figure 3. D100 Cevizlibağ and D100 Zincirlikuyu Sections

these observations, six locations (TEM Hasdal, D100 Cevizlibağ, D100 Otakçılar, D100 Zincirlikuyu, Basın Ekspres-Kuyumcukent, and D100 Bahçelievler Ömür Plaza) were identified where cross-hatched area violations were frequently made by vehicle drivers. During this process, some discontinuity of live camera streaming by IBB TKM (Istanbul Metropolitan Municipality Traffic Control Center) occurred in the network. Also, the view angles of cameras were shifted by IBB TKM on occasion (for example for accidents or unexpected events) or on a solely random basis. After communication with the authorized personnel in IBB TKM it was decided to keep the view angles of traffic cameras constant for the morning and evening peak periods at D100 Zincirlikuyu and D100 Cevizlibağ sections (see Fig. 3).

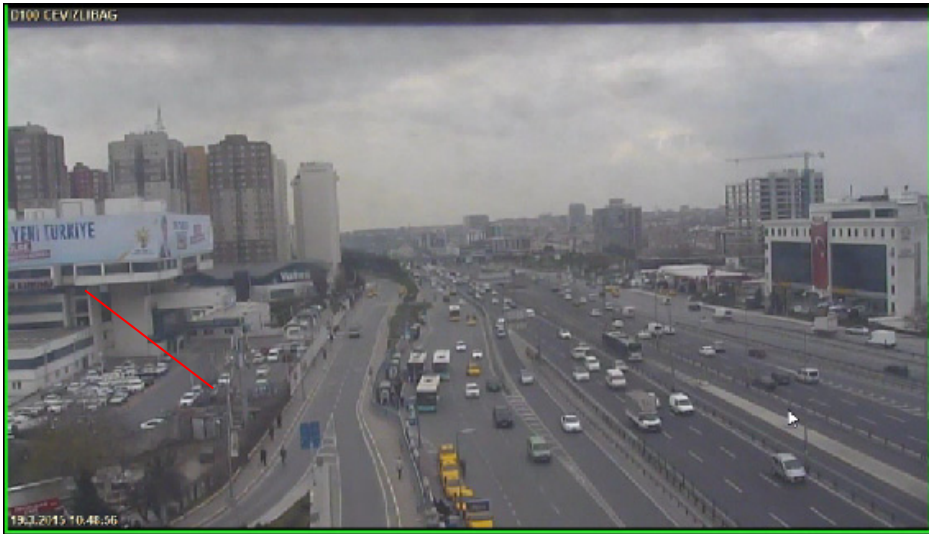
Figure 4. D100 Cevizlibağ observation section

Traffic counts were made between the same reference points which were chosen on the road side to form a section. Examples of these can be seen in Figures 4 and 5. In Figure 4, it can be seen that traffic counts were made in the shaded area for the one-way four lane section of the D100 Cevizlibağ location. First, the total number of vehicles crossing from the section was counted and then on a one-minute basis, the number of all passing and cross-hatched area violating vehicles was noted as shown in Table 1. The same methodology was applied for the D100 Zincirlikuyu section. In Figure 5, the counting section can be seen. Counts were made from the direction of the European side to the Asian side. After this, the vehicles were divided by type, as can be seen in Table 1. All video recordings that were used for the observations and counts were approximately 45 minutes. Vehicle counts were made by stopping the video player system every minute. Every one minute of video records was viewed 8 times (for determining the total number of vehicles that crossed the section, the total number of cross-hatched area violating vehicles, the number of three different vehicle types that crossed the section and the number of cross-hatched area violating vehicles by the three vehicle types, which totals 8 counts). The total video viewing time is approximately 2160 minutes because we made counts at 2 different sites (D100 Cevizlibağ and D 100 Zincirlikuyu) and on 3 different days. This total duration (2160 minutes) is only the non-stop time of viewings. It excludes the time taken when the videos were stopped and notes were taken.

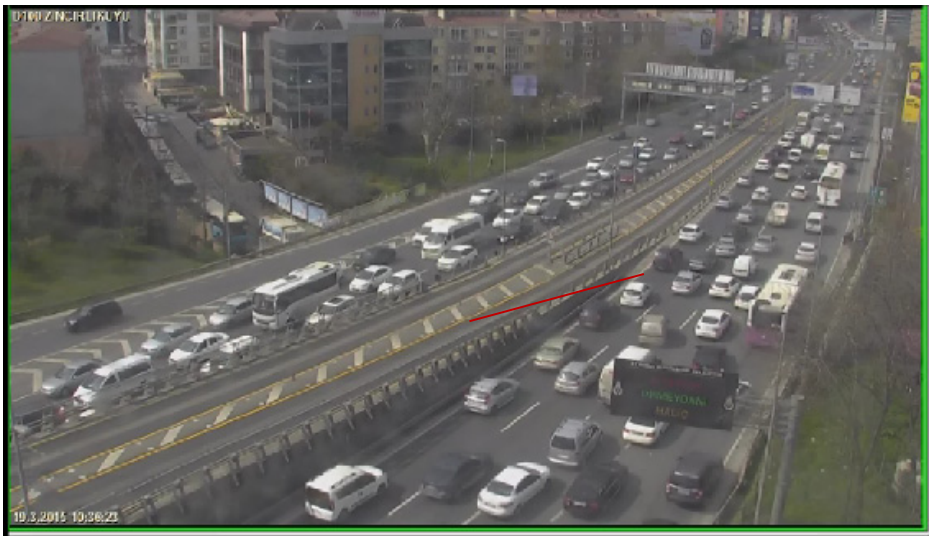
Figure 5. D100 Zincirlikuyu observation section

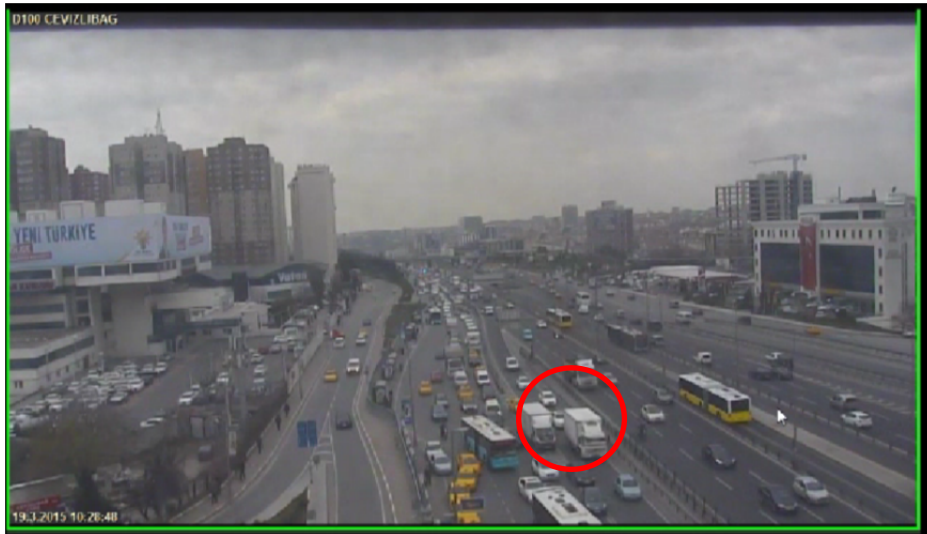
Figure 6. Heavy vehicle shaded area violation at 19.03.2015; time: 10:28:40

Here, we present the graphical representations of the vehicle counts for cross-hatched area violations as well as the general findings. Some snapshot screen examples for the March 19, 2015 morning period cross-hatched area violations can be seen in Figures 6 and 7. As a result of the analysis of the video recordings, we calculated that 17% of the vehicles violated the cross-hatched area at that section. Detailed counts show that 11% of these are passenger cars, 0.5% are heavy vehicles and 5.5% are commercial vehicles. Another interesting observation is that toward noon, the cross-hatched area violations decreased.

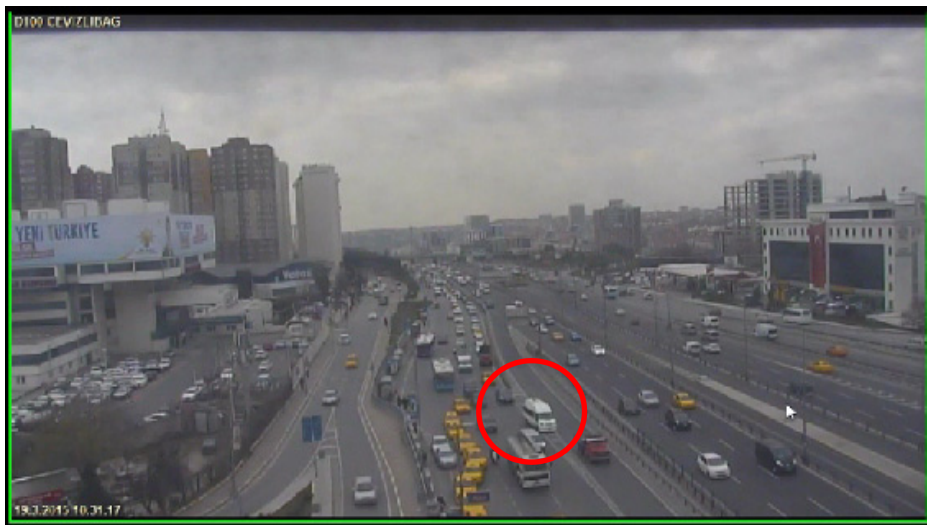
Figure 7. Another shaded area violation snapshot at 19.03.2015; time: 10:31:17

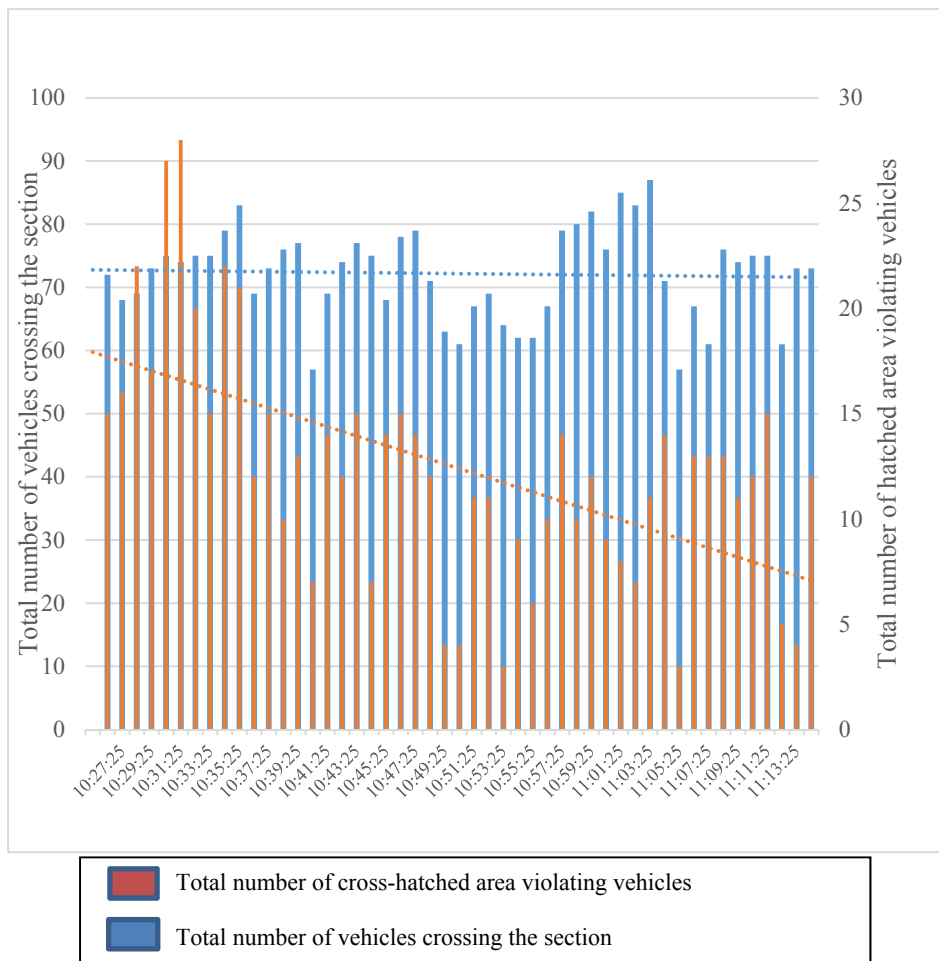
Figure 8. Total number of vehicles crossing the count section and total number of cross-hatched area violating vehicles per minute on 19.03.2015

From Figure 8 we may say the total number of vehicles crossing the observation section is almost steady though the number of cross-hatched area violating vehicles decreases towards the end of the peak period. It is possible that the reason for this is that more regular traffic flow occurs toward noon.
