## Research Article

# DYNAMIC BEHAVIOUR OF HISTORICAL BAYBURT GRAND MOSQUE

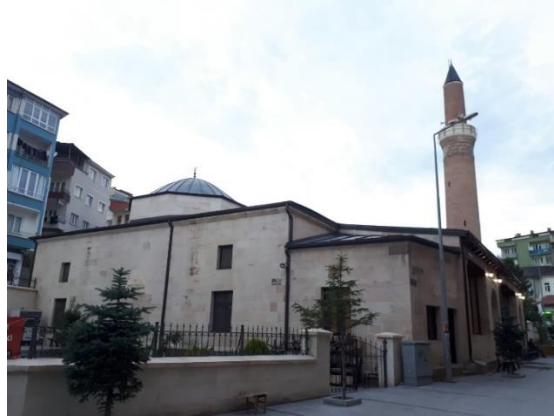
**Figure 6.** Bayburt Ulu Mosque

As a numerical application, Bayburt Ulu Mosque in the city center of Bayburt is chosen. The Mosque was built in 1282 by Seljuk Sultan II. Gıyaseddin (Figure 6-7).

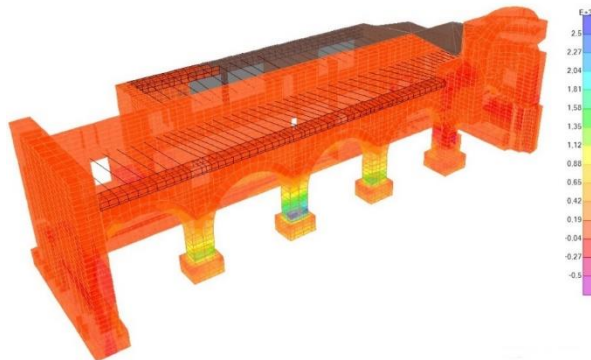
The tensile and compressive values of the mosque and the strength capacity of the wall are given in Table 3. Figure 9-11 shows the biggest regressions of the mosque which was subjected to the 17 August 1999 Kocaeli, 12 November 1999 Düzce and 13 March 1999 Erzincan earthquakes. Figure 12 shows the highest pressure stress in all three earthquakes.

**Figure 9.** Maximum S33 tensile stresses of the mosque subject to Erzincan earthquake

As it can be seen from Table 3, the highest pressure and tensile stress values occur in Düzce earthquake. The strength capacity is calculated using the values obtained from this earthquake. It is thought that damage will not occur because the compressive stresses do not exceed the compressive stress of the masonry structure in all earthquakes. It is thought that the damage will occur because S33 tensile stress is 2.18 MPa exceeds the tensile stress of the masonry structure subjected to Düzce and Erzincan earthquake. It should be noted that the tensile strength capacity of the masonry structure increases up to 85% in case of Kocaeli earthquake. This percentage shows that the stone is close to the tensile strength capacity. As shown in Figure 9-11, the greatest tensile stress occurs in the third of the left-hand arch feet in the Qibla direction in the structure subjected to three earthquakes. The maximum pressure stress occurs at the same location (Figure 12).

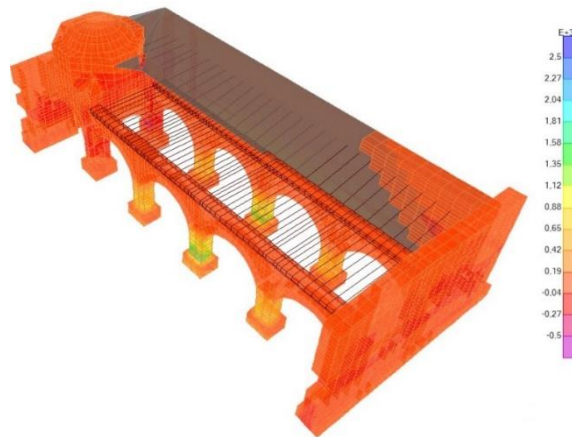
**Figure 10.** Maximum S33 tensile stresses of the mosque subject to Kocaeli earthquake

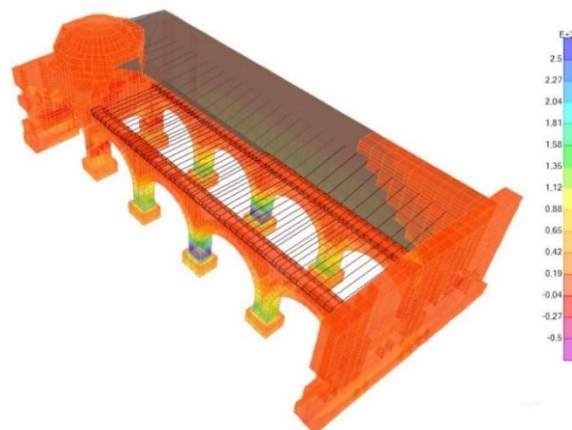
**Figure 11.** Maximum S33 tensile stresses of the mosque subject to Düzce earthquake

- The greatest stress values in the historical mosque are obtained when the building is subjected to the 12 November 1999 Düzce earthquake.
- Since the compressive stresses are not greater than the compressive stresses of the masonry structure, it is considered that the mosque will not be damaged due to compressive.
- The greatest tensile stress occurred on the third belt leg, which is believed to cause damage. These damages are thought to be solved by FRP covering and bracing processes.
