Journal of Sustainable Construction Materials and Technologies Web page info: https://jscmt.yildiz.edu.tr DOI: 10.14744/jscmt.2021.04

Evaluation of concrete pavers affected by Manavgat wildfires

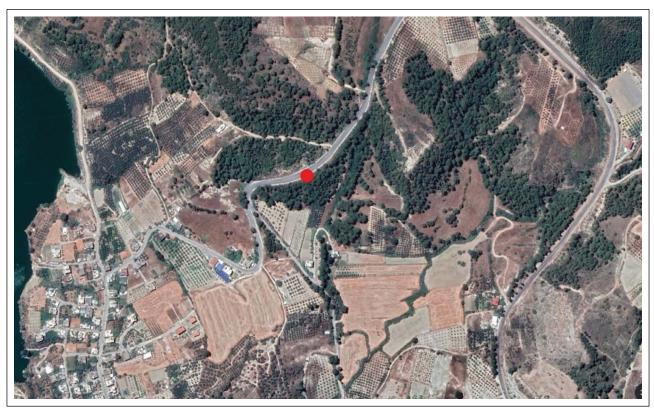
Figure 1. Manavgat-Oymapınar Neighborhood.

In order to obtain the materials in this research, the Manavgat fire area was investigated. The area shown in Figure 1 is the Oymapınar neighborhood. It is clearly seen that this region, where forest and habitats are very close to each other, is WUI.

The field marked red in Figure 1 is the area with the most affected pavement from the fire. It was decided to take the samples from this area. When the paving stones were examined, it was seen that there were completely burned, half-burned and unburned concrete paving stones in the same area. It is planned to take three samples from all three combustion conditions to compare them with each other in terms of the mean value of compressive strength. The pavement affected by the fire is shown in Figure 2.

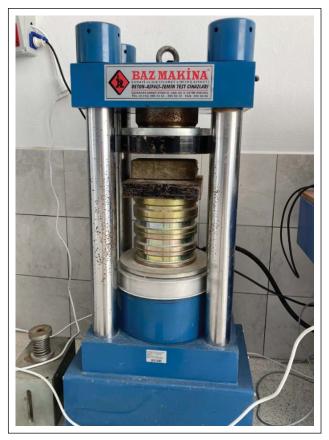
Figure 4. Compression testing machine.

The paving stones were tested in the pressure machine in the Civil Engineering Laboratory of Alanya Alaaddin Keykubat University. The experimental setup is shown in the Figure 4.

All experiments were successfully completed, and compressive strengths were obtained in accordance with the standard of BS6717 [14, 15]. The compressive strengths measured as a result of the tests are shown in the Table 2. According to the results obtained, the mean value of compressive strengths of unburned, half-burned, and completely burned stones were 36.04 MPa, 49.51 MPa, and 50.83 MPa, respectively.
