Research Article

HUMAN FACTORS IMPLICATIONS ON SHIP BRIDGE DESIGN

The aim of this paper is to analyse human errors in grounding accidents according to the Marine Accident Investigation Branch of UK (MAIB) Database. In the analysis it was found that 82% of grounding accidents were related to human factor. The main aim is to identify the effect of **human errors** on deterioration of **navigation safety** with a view of **improving future ship bridge design** according to the **IMO Human Centered Design (HCD)** approach.

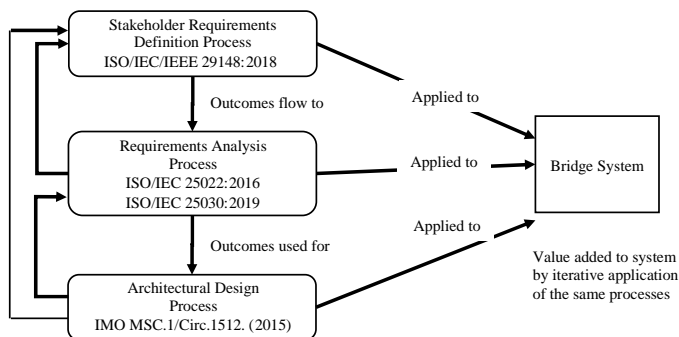
The research set of accident data gathered from the accidents involves the UK flag ships worldwide and the ships in the UK waters from MAIB database and the MAIB root causes taxonomy was selected to be used in this study. The terms of MAIB Human Factor Taxonomy are used in MAIB Accident Investigation Process [26]. The findings were comparatively analyzed with the user needs, gaps and anomalies which were mentioned in related IMO documents to underline the role of human factors on grounding accidents. And finally the possible industrial recommendations in trial process which have been developed according to the adopted International Standardization Organization (ISO) Iterative Application Processes of Human System Integration Concept throughout the life-cycle of systems and software [27] and finally, Human Factor Quality Requirements of Information and Communication (ICT) Products [28] were used to propose possible industrial recommendations in trial process. (see Figure 2.)

Figure 2. Adopted Application Processes (Adopted from ISO/IEC/IEEE 29148)
